## COST-EFFECTIVE TREATMENT OF EXISTING GUARDRAIL SYSTEMS

A THESIS

For the Degree of Master of Science

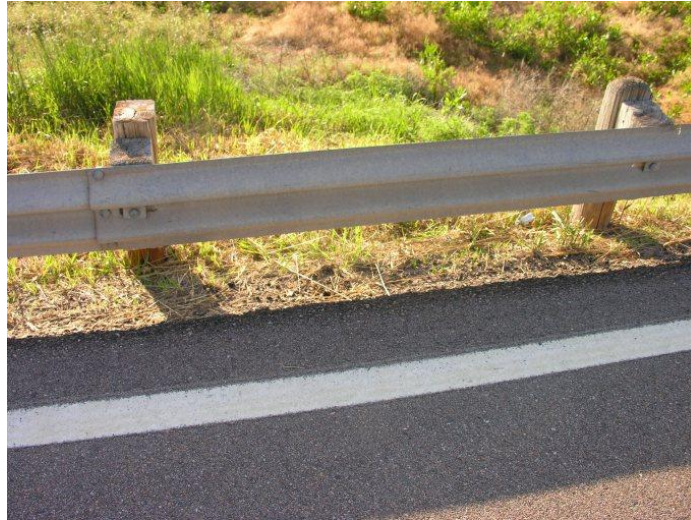
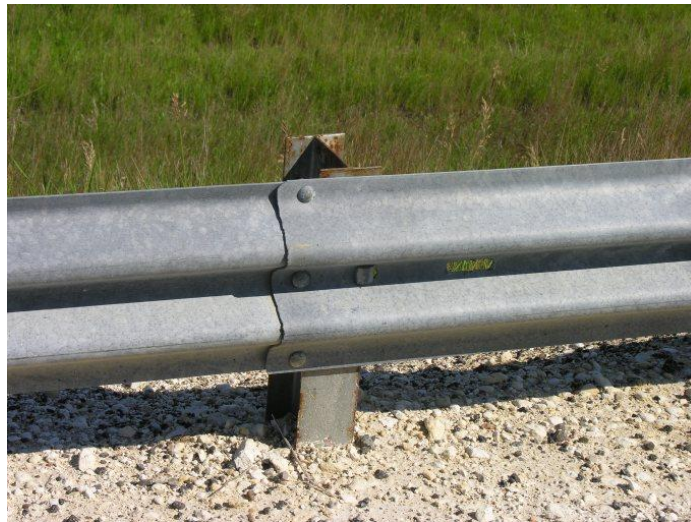
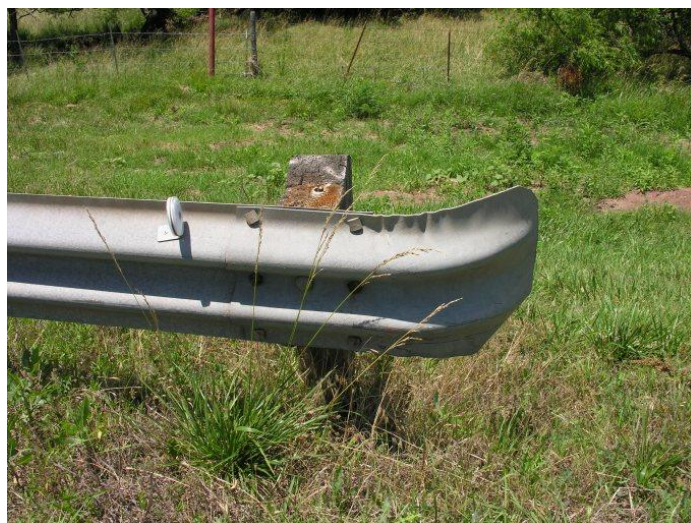
were vertical rather than horizontal. Also, the modified W-beam splices utilize only three  $\frac{5}{8}$  in. (16 mm) bolts, instead of eight. The systems utilized both round and rectangular wood posts, which had typical cross sections of a 6 in. diameter (152 mm) and 5½ in. x 7½ in. (140 mm x 191 mm), respectively. Only three of the nine systems had wood blockouts. The remaining systems did not use blockouts. Spoon terminals were the only end treatment found on all these modified W-beam barriers, which act as blunt ends to impacting vehicles. Also, none of these end terminals provided any type of anchorage, giving them little redirective strength to resist an impacting vehicle. Three of the nine systems utilized 6 ft - 3 in. (1.9 m) post spacings. The rest had 12 ft - 6 in. (3.8 m) spacings. The modified W-beam guardrail systems shielded slope and culvert hazards. Typically, these systems had a top rail height ranging from 11 in. to 29 in. (279 mm to 737 mm), with an average of 21.7 in. (551 mm) when measuring the lowest point of each barrier system. Photographs of these systems are shown in Figure 24.

Figure 24. Examples of Deviations from Standard W-Beam Guardrail Systems

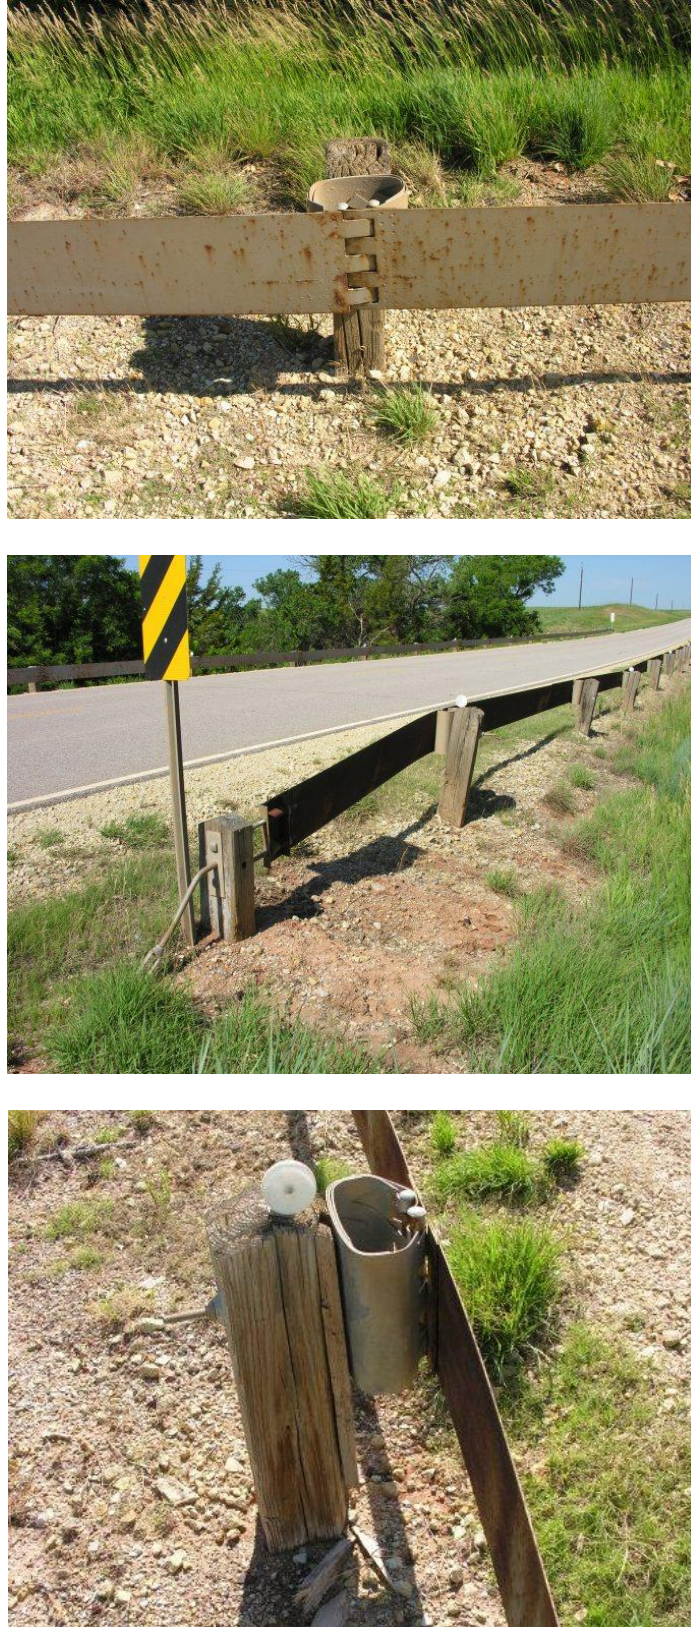
Figure 25. Examples of Flat-Panel Systems

Three of the 68 barrier systems documented were steel, flat-panel barriers. This barrier utilized a steel panel rail with an average thickness of 0.126 in. (3.2 mm). The flat-panel system used rectangular 5-in. x 7-in. (127-mm x 178-mm) wood posts with circularly looped, steel tube blockouts. The rail was spliced at each post with two steel ½-in. (13-mm) diameter pins. The upstream and downstream end treatments of all flat-panel systems were blunt ends with little or no anchorage. All three flat-panel systems were shielding slopes. Examples of the flat-panel systems are shown in Figure 25.

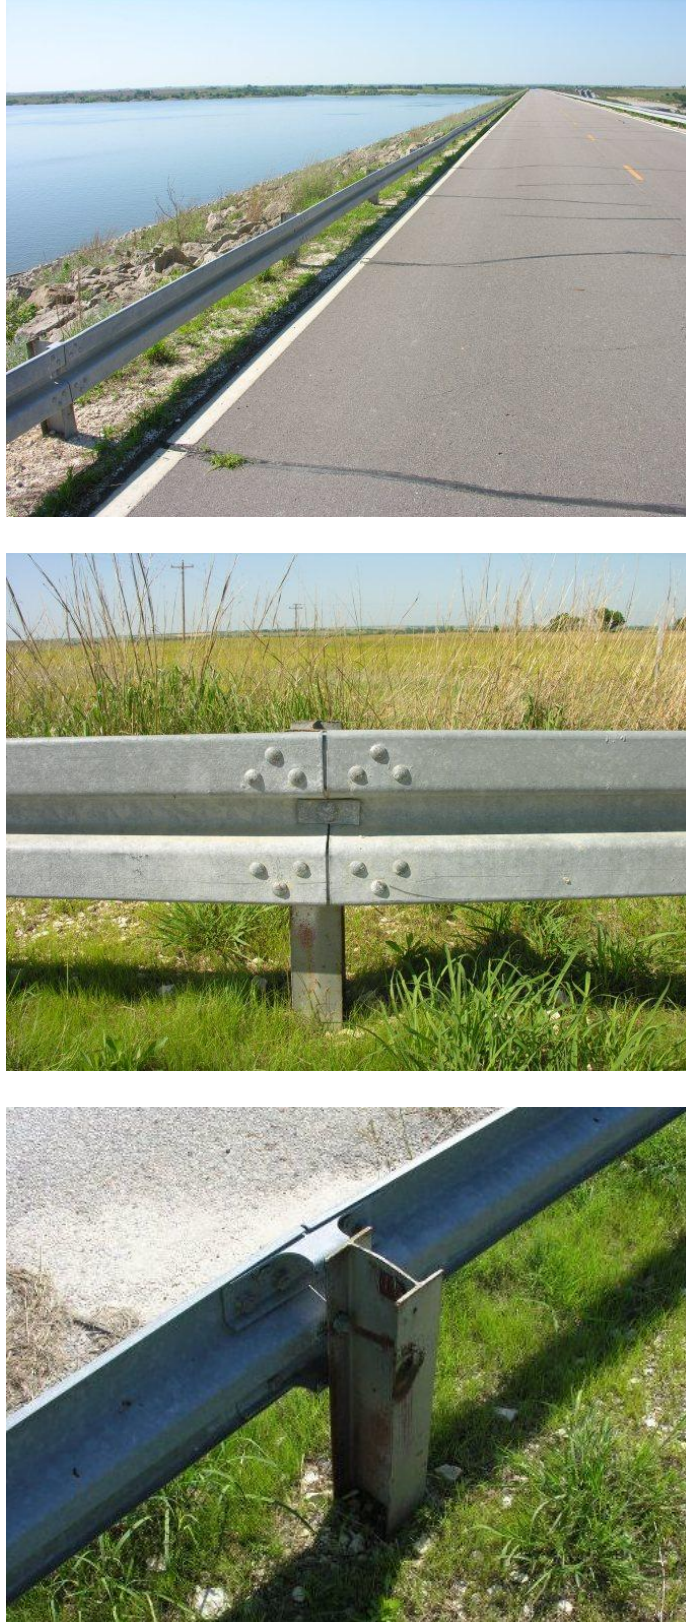
One barrier documented during the field investigation was regarded as a channel rail. The barrier appeared to be in good condition. The steel channel barrier was very similar to a standard W-beam guardrail and utilized steel W6x9 (W152x13.4) posts. Post spacing for the channel rail was 12 ft - 6 in. (3.8 m). Two steel brackets separated the rail from the posts. The upstream and downstream end treatments of the channel rail were blunt ends with no anchorage. Rail splices were located at each post location with twelve ⅝-in. (16-mm) splice bolts. The steel channel rail shielded the slope of a dam. Photographs of the channel rail system are shown in Figure 26.

Figure 26. Examples of Channel Rail Systems

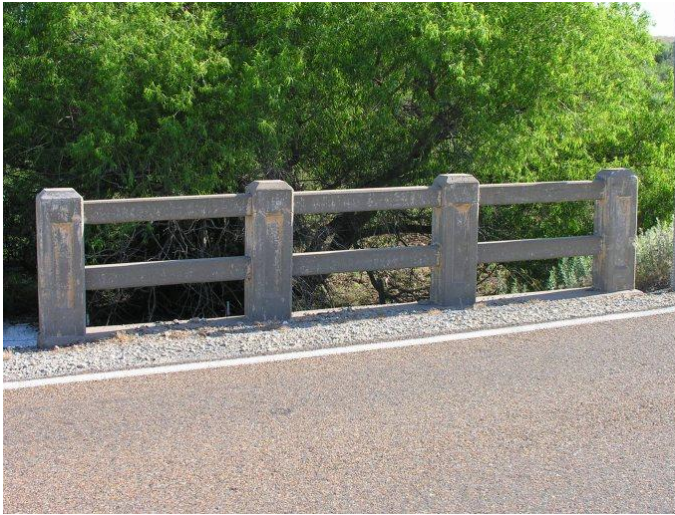
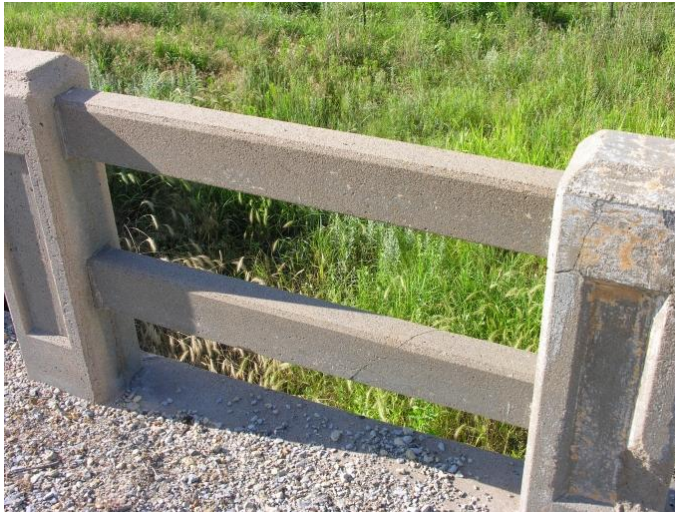
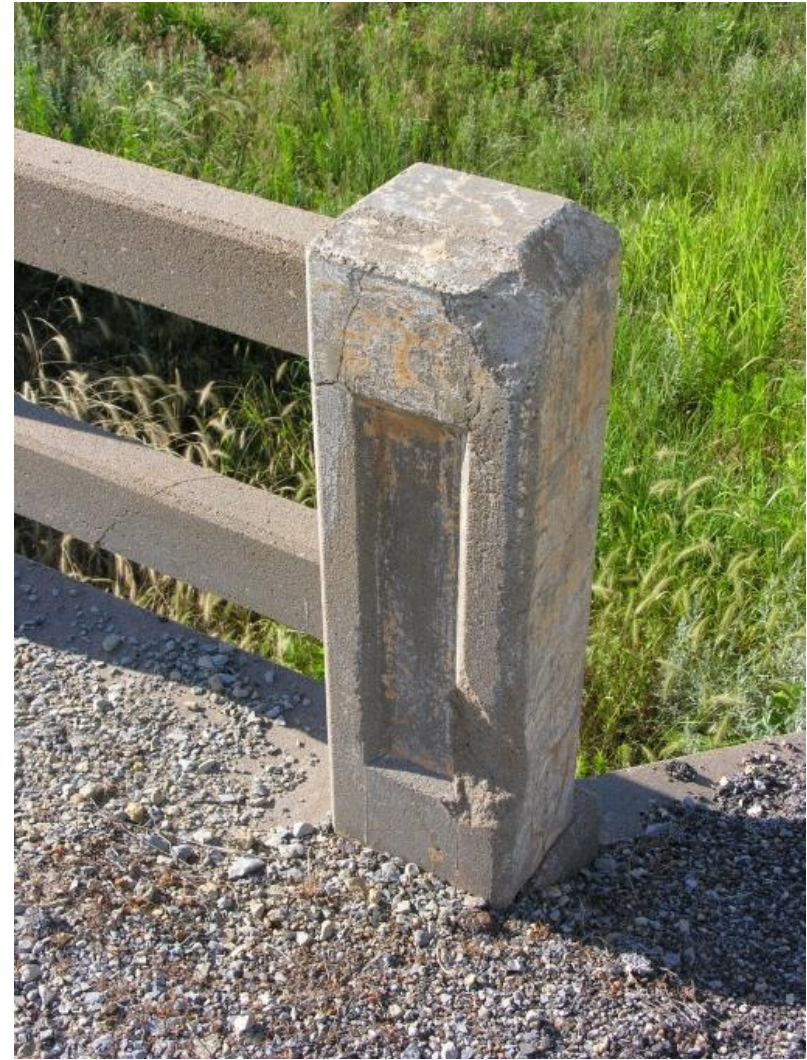
One concrete rail with concrete posts over a culvert was discovered in the field investigation. The barrier was in good condition with minor cracks. The posts were 12 in. x 9 in. x 39 in. (305 mm x 229 mm x 991 mm) with a 48-in. (1,219-mm) post spacing. The barrier was not equipped with an end treatment. This barrier could pose a more severe hazard than the hazard it is shielding. Photographs of the concrete post and rail system are shown in Figure 27.

Figure 27. Examples of Concrete Post and Rail System
